| Research Article

The Effect of Mangrove Conditions on Shoreline Changes at Mangrove Beach, Senagaga Village, Lawan, Perbaungan District

Abstract: This study aims to analyze the influence of mangrove vegetation conditions on shoreline changes in Mangrove Beach, Sei Naga Lawan Village, Perbaungan District, Serdang Bedagai Regency. The background of this research is based on the deterioration of mangrove conditions experienced by coastal areas and the increasing degradation of mangrove vegetation due to human activities. The method used in this study is a quantitative descriptive approach with data collection through field observations, and analysis of Sentinel-2 satellite images. Observations were made at 10 mangrove vegetation sampling points and analysis of shoreline changes during the 2020–2025 period. The results showed that areas with high density mangroves and healthy vegetation experienced less abrasion compared to areas with damaged or sparse mangroves. Spatial analysis using ArcGIS software shows a deeper shift of coastline to land in areas that are losing vegetation cover. These findings reinforce the important role of mangroves as natural protectors of beaches that are

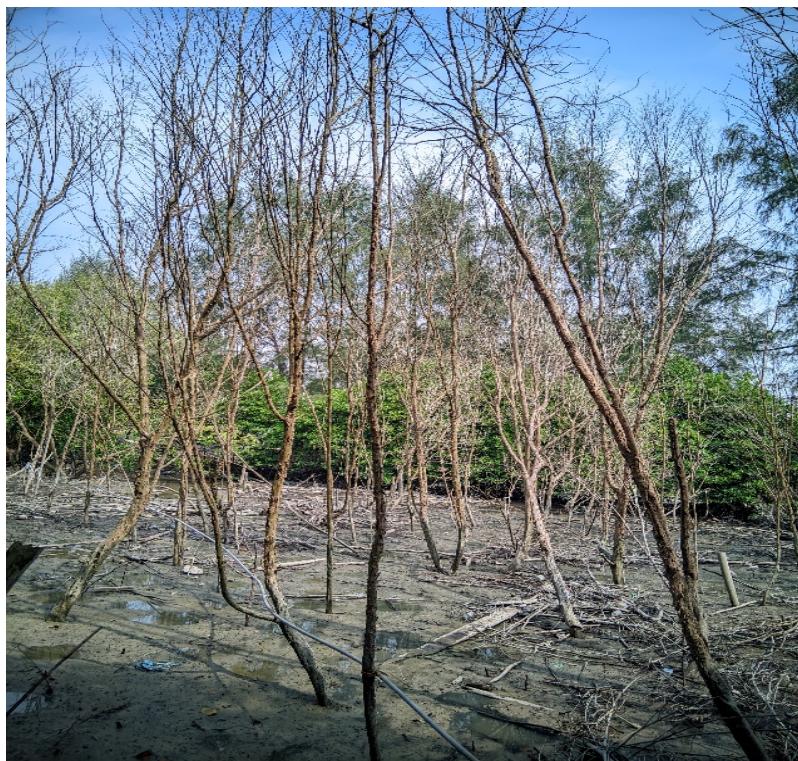
Although some spots have a reasonably high density (e.g., Points 6 and 7), visual observations show that the leaves are only fertile at the top, while the trunk and middle part of the tree appear barren. It indicates environmental stress, perhaps due to water quality, extreme salinity, or pollution. Some spots also show conservation success, characterized by young mangroves up to 2 meters high with lush, green leaves throughout, growing evenly and in good health. In contrast, vegetation conditions in some other areas show severe damage due to sewage pollution, as seen in the following Photo, where the stems look dry, dead, and contaminated with solid waste.

Figure 1 | The Condition of Mangroves Damaged by Waste (Source: Data Processing Results, 2025)

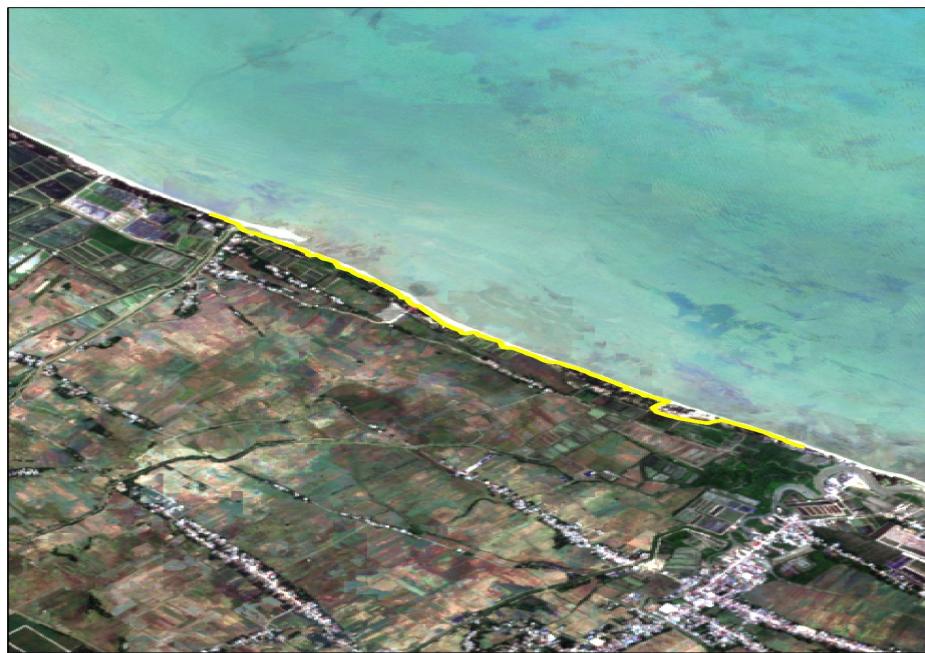
Figure 3 | Shoreline Conditions 2025 (Source: Data Processing Results, 2025)

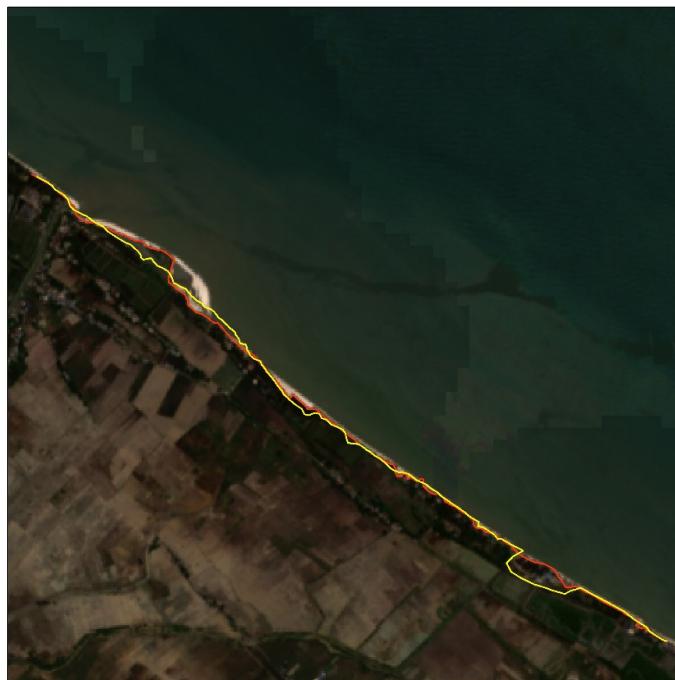
Figure 4 | Results of Coastline Digitization in 2020-2025 (Source: Data Processing Results, 2025)

The damaged mangrove condition in part of Sei Naga Lawan Beach reduces the beach's natural ability to withstand abrasion. This is in [Dalimunte et al. \(2025\)](#), who stated that mangrove damage can increase the vulnerability of coastal areas to abrasion, due to the loss of mangrove root function in retaining sediment and reducing wave strength. The results of the coastline map analysis (Figure 2) indicate that significant coastal abrasion has occurred over the last five years. The coastline in 2025 (yellow line) will likely hang more to land than the coastline in 2020 (red line). This change in coastline is especially noticeable in areas with degraded

mangrove vegetation. Parts of the coastline that lost protective vegetation experienced more profound abrasion shifts, while regions with vegetation conservation tended to be more stable.

The Pearson correlation coefficient (r) obtained is -0.72 , indicating a relatively strong negative correlation. This means that the higher the density of mangroves in an area, the less likely it is to cause abrasion. These results are consistent with visual findings on shoreline digitization overlay maps, where areas with dense and healthy vegetation show better shoreline stability. This analysis suggests that the variable density of mangrove vegetation can be used to predict coastal change dynamics in tropical coastal areas, such as Sei Naga Lawan Village.
